**Flood Control Project Maintenance
Levee Inspections**

Maintenance Issue Types Only, Levee Inspection Report By Mile - Fall 2016

Reclamation District No. 2031 Elliot

| Waterway | Bank | Unit Miles | Inspection Start/End | Inspector |
|---|---|---|---|---|
| Unit No. 01 Stanislaus River | Left | 7.07 | 10/20/2016 10/20/2016 | Maksim Khashchuk |

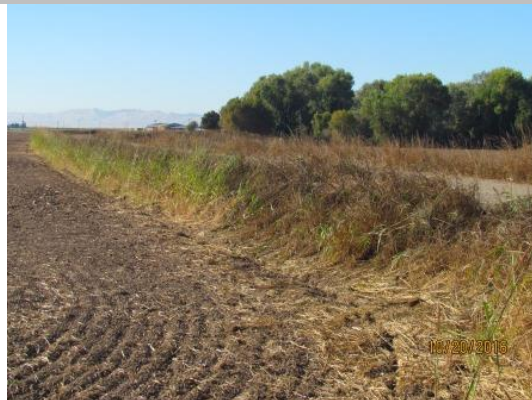
Photo 1 of 1 : FA_2016_RD2031_307_31_20161024_00088.jpg

View of the vegetation on the landside levee slope.

| V1 : Control annual grass and weeds on the levee slopes and easements. | | | | | |

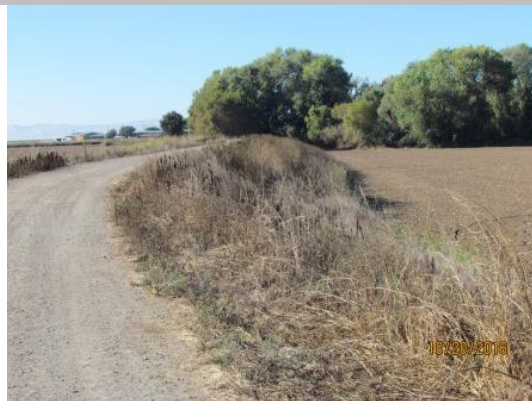
Photo 1 of 1 : FA_2016_RD2031_307_32_20161024_00089.jpg

View of the vegetation on the waterside levee slope. Looking downstream.

| V1 : Control annual grass and weeds on the levee slopes and easements. | | | | | |

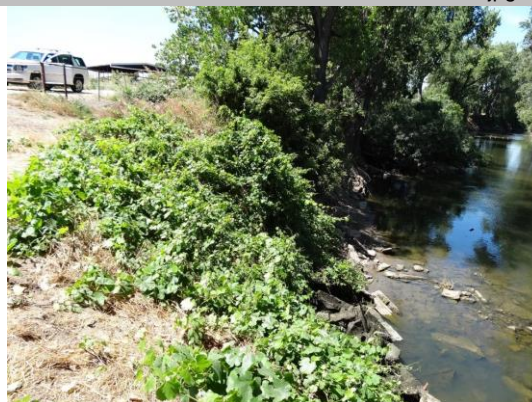
Photo 1 of 2 : SJR2016_RD2031U01RM0.48_1.jpg

| 10/19/2010: No significant change observed on site. Sloughing of the bank is occurring adjacent to an irrigation outlet structure. There is moderate to heavy vegetation along the bank that is well established. Broken chunks and slabs of concrete are used as rip rap and line the outside of the irrigation outlet structure. However, much of the rip rap along the slope is sloughing and could possibly lead to future slope instability. | | | | | |
| 08/20/2009: No major change observed since last visit; 1 inch fissure cracks developing on the slope; rip rap is showing signs of sloughing; recommend as local maintenance issue; site was previously rated "U". | | | | | |

Direct view of the site.

| 08/05/2010: Recommended as a local maintenance issue, per CLRO. | | | | | |

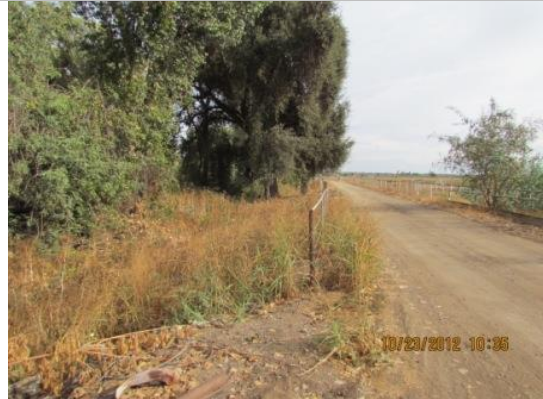
Photo 2 of 3 : FA_2016_RD2031_307_2_20160914_00004.jpg

View of vegetation on waterside slope. Facing upstream.

V2 : Remove the wild growth other than native grasses from the levee slopes.

Remove vegetation 20 feet away from the levee crown.

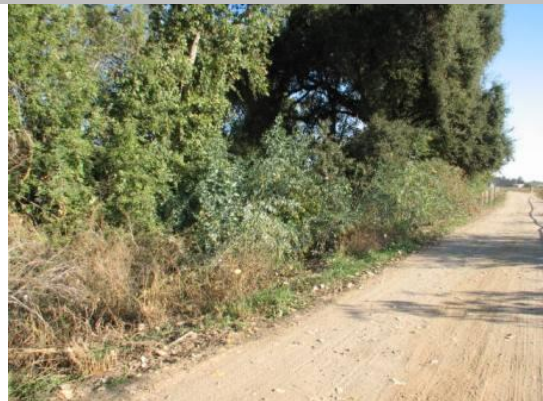
Photo 3 of 3 : FA_2016_RD2031_307_2_20160914_00005.jpg

10/26/2011 Updated photo of waterside vegetation.

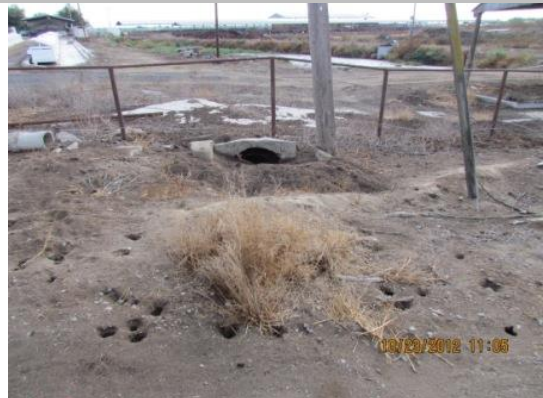
Photo 1 of 1 : FA_2016_RD2031_307_36_20160914_00021.jpg

View of rodent burrows on landside slope.

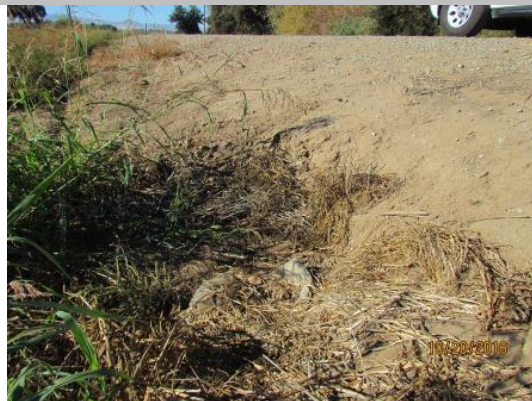
Photo 1 of 1 : FA_2016_RD2031_307_42_20161024_00091.jpg

View of the erosion of the landside levee slope.

| E2 : Schedule repair of erosion site prior to the next inspection. | | | | | |

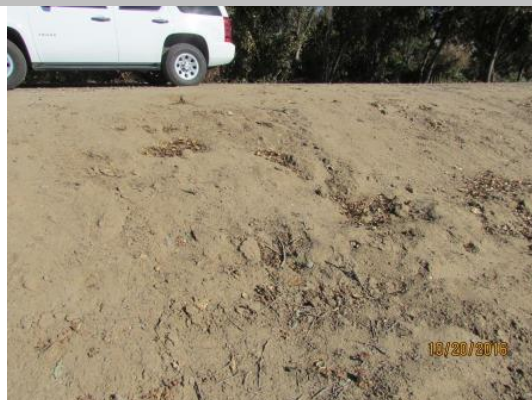
Photo 1 of 3 : FA_2016_RD2031_307_59_20161024_00092.jpg

| Some of the rodent holes have collapsed. | | | | | |

View of the rodent holes on the landside levee slope.

| A3 : No rodents visible, but rodent burrows visible; need to backfill and compact or grout burrows. | | | | | |

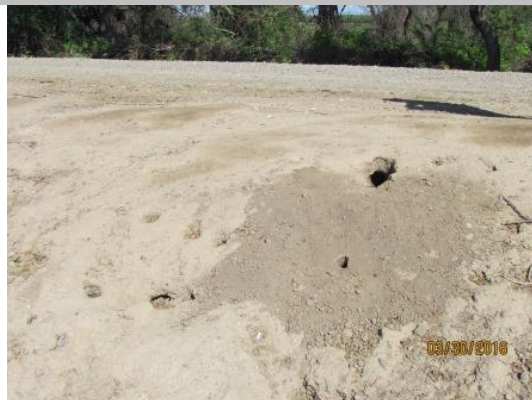
Photo 2 of 3 : FA_2016_RD2031_307_59_20160914_00036.jpg

Another view of the rodent hole on the landside levee slope.

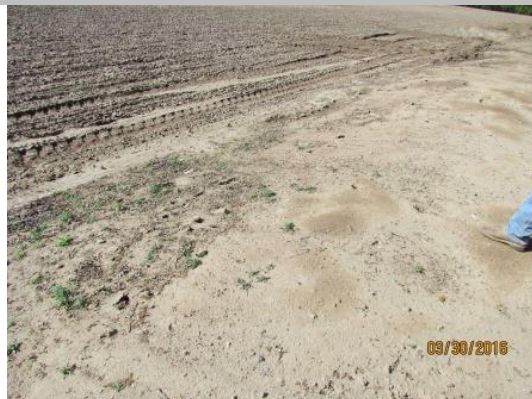
Photo 3 of 3 : FA_2016_RD2031_307_59_20160914_00035.jpg

| Some of the rodent holes have collapsed. | | | | | |

View of the multiple rodent holes on the landside levee slope.

| A3 : No rodents visible, but rodent burrows visible; need to backfill and compact or grout burrows. | | | | | |

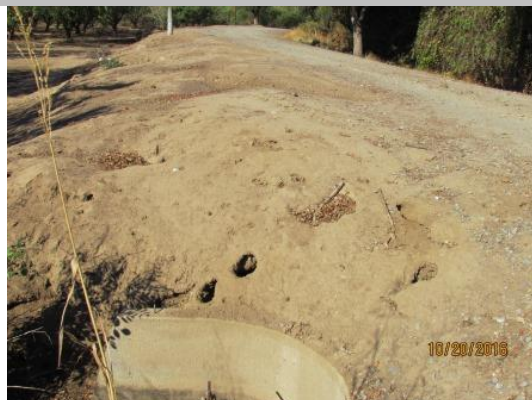
Photo 1 of 1 : FA_2016_RD2031_307_44_20161024_00093.jpg

View of the rodent holes on the landside levee slope.

| A3 : No rodents visible, but rodent burrows visible; need to backfill and compact or grout burrows. | | | | | |

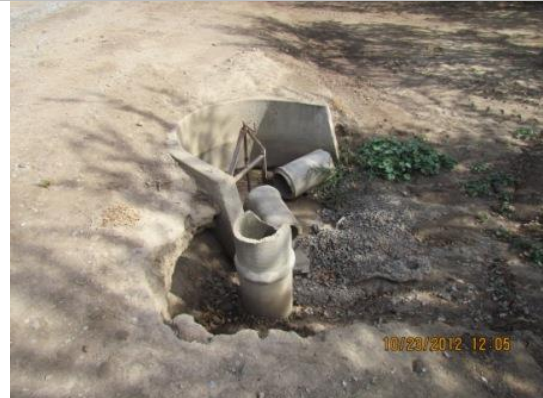
Photo 1 of 2 : FA_2016_RD2031_307_3_20160914_00006.jpg

View of the erosion site on landside slope, facing upstream.

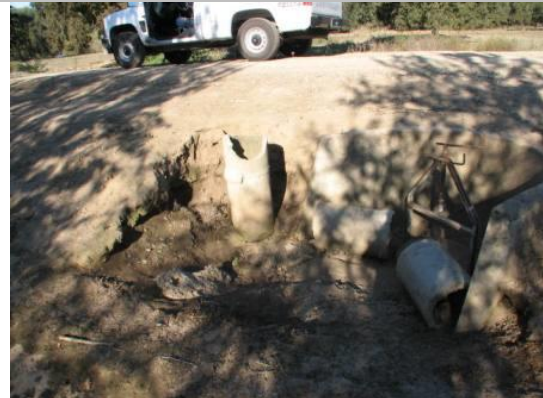
Photo 2 of 2 : FA_2016_RD2031_307_3_20160914_00007.jpg

10/26/2011 Active erosion into the levee prism around irrigation standpipe.

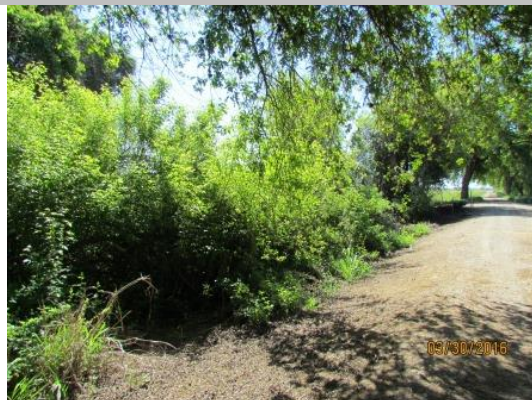
Photo 1 of 1 : FA_2016_RD2031_307_29_20160914_00016.jpg

View of the tall vegetation on the landside levee slope.

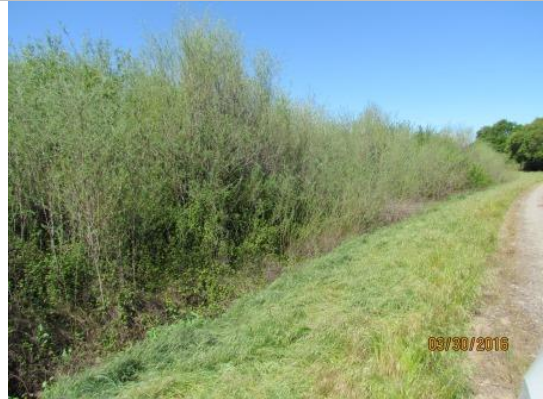
Photo 2 of 3 : FA_2016_RD2031_307_33_20160914_00018.jpg

Typical view of the tall vegetation on the landside levee slope and toe in this area.

| Trim back woody vegetation at least 15 feet away from the landside levee toe. | | | | | |

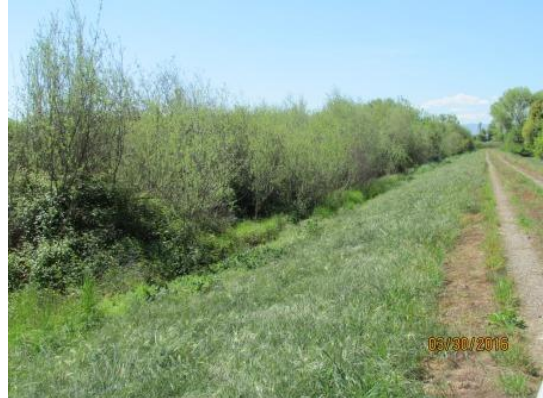
Photo 3 of 3 : FA_2016_RD2031_307_33_20160914_00019.jpg

Another view of the tall vegetation on the landside levee slope and toe.

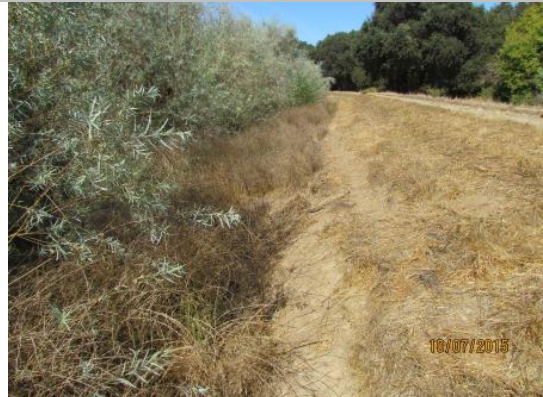
Photo 1 of 1 : FA_2016_RD2031_307_57_20160914_00033.jpg

| Erosion at the landside levee toe. | | | | | |

View of the 18 inch vertical cut at the landside levee toe.

| E2 : Schedule repair of erosion site prior to the next inspection. | | | | | |

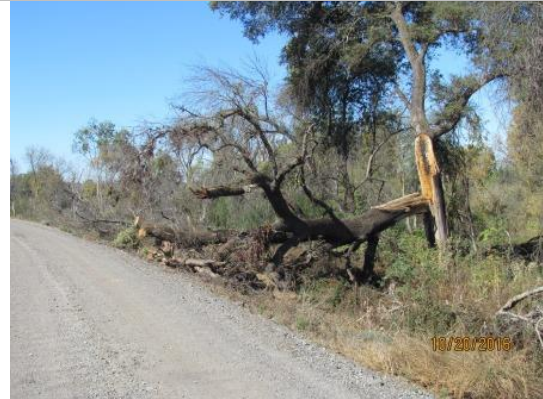
Photo 1 of 1 : FA_2016_RD2031_307_56_20161024_00100.jpg

View of the broken tree limb on the levee slope.

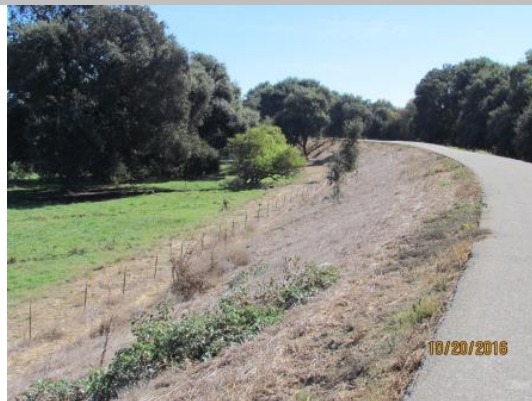
Photo 1 of 1 : FA_2016_RD2031_308_16_20161024_00033.jpg

| No unwanted vegetation on levee slope. | | | | | |

View of acceptable vegetation control on the levee slope.

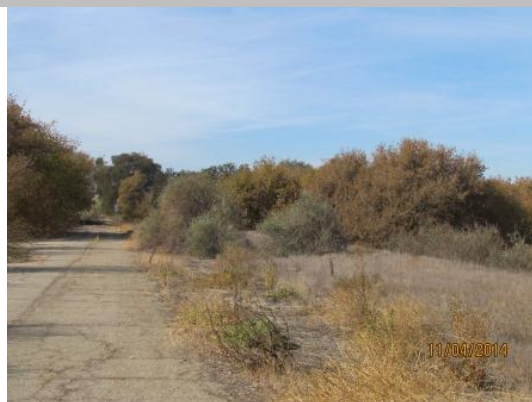
Photo 1 of 1 : FA_2016_RD2031_308_21_20160914_00007.jpg

View of overgrown vegetation on the levee crown.

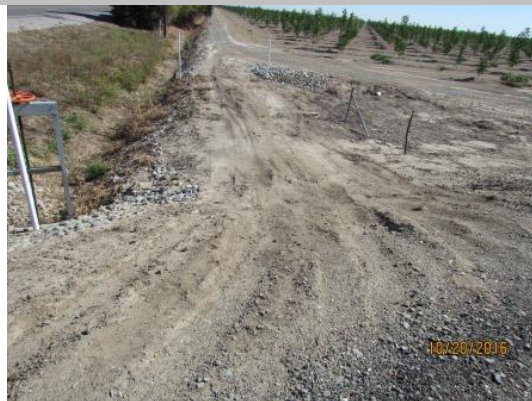
Photo 1 of 1 : FA_2016_RD2031_308_17_20161024_00036.jpg

View of the tire tracks on the levee slope.

| S3 : Repair the levee slope damaged by vehicle traffic and prevent access where possible. | | | | | |

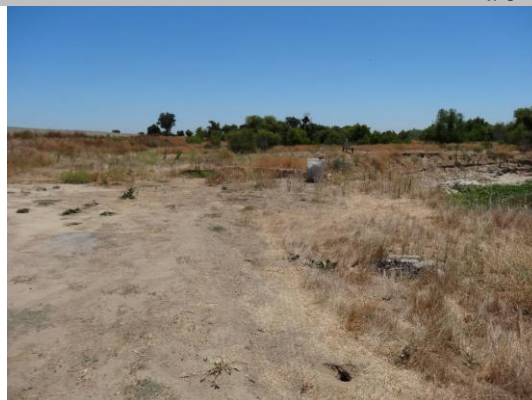
Photo 1 of 3 : SJR2016_RD2031U02RM78.7_1.jpg

| 07/08/2016: The erosion in the berm was found further progressed toward levee toe. | | | | | |
| 08/18/2011: No significant change observed on the site. Dead trees and animal activities are visible. The closest point of the erosion site to the levee toe is about 100 ft. | | | | | |
| 10/19/2010: There is active scouring occurring on the bank due to the nature of the flow and the lack of armor protection. There is also a fallen log immediately downstream of where the erosion has occurred and is protruding outward, possibly creating an eddy and scouring the bank. With the remaining 100-foot wide berm, the levee prism is not yet affected. However, the bank will continue to degrade, and eventually intrude into the levee prism if no protection is put in place. Erosion site is recommended for annual assessment and monitoring during flood events. [2016 Site ID:RD2031U02RM78.7] | | | | | |

Looking downstream of the erosion site.

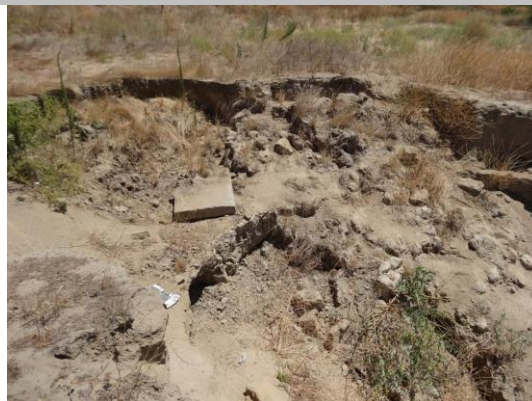
Photo 2 of 3 : SJR2016_RD2031U02RM78.7_3.jpg

Close view of the pocket erosion.

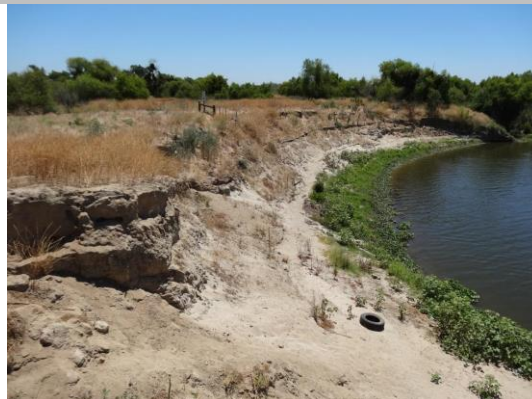
Photo 3 of 3 : SJR2016_RD2031U02RM78.7_4.jpg

Close view of the erosion.
